AFWAL-TR-87-4086

# **NONDESTRUCTIVE EVALUATION OF CARBON-CARBON COATINGS**

**D.C. Copley  
GE Aircraft Engines  
1 Neumann Way  
Cincinnati, Ohio 45215**

**Final Report for Period August 1984 - February 1987**

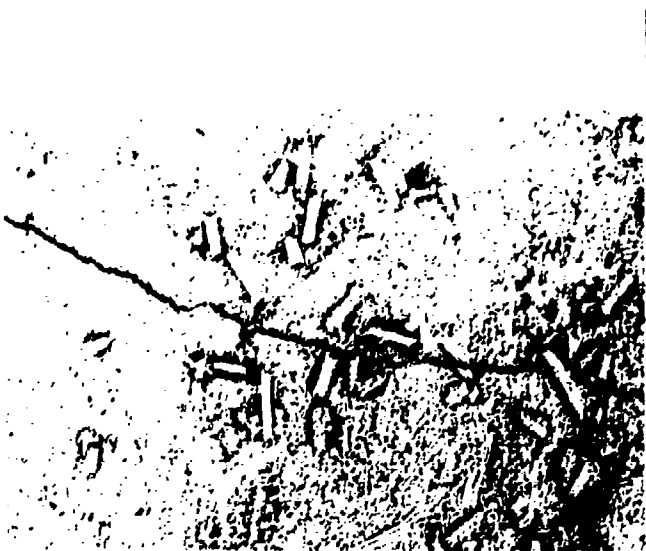
Figure 16. Surface Alterations due to Thermal Exposure in an Oxidizing Environment (Hour Heat Soak).

(a) As-Received Condition  
(Dark Areas Represent  
Surface-Charging)

(b) After Exposure to 2450° F  
in Air - Top Surface

(c) After Exposure to 2450° F  
in Air - Bottom Surface

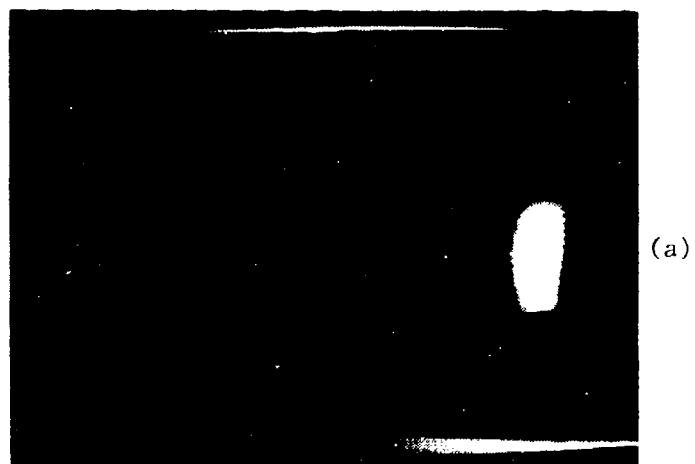
Figure 34. Infrared Scan of Specimen K650-71.

Infrared (IR) testing was performed on a number of the coupons at this stage in order obtain feasibility data on the IR technique. The technique used a YAG laser operating at 10 watts continuous wave, with a 1.064- $\mu$ m wavelength. Beam size was 2 cm high by 1 mm wide on the test coupon. The beam was swept across the coupon at a rate of approximately one inch per second. Figure 34 shows scan results from Coupon 71, with the beam sweeping from right to left. Figure 34b shows local heating around a surface oxidation pit (top center). Figure 34c shows a smaller but similar feature (left center). Both features could be seen, by visual examination, to penetrate the coating.

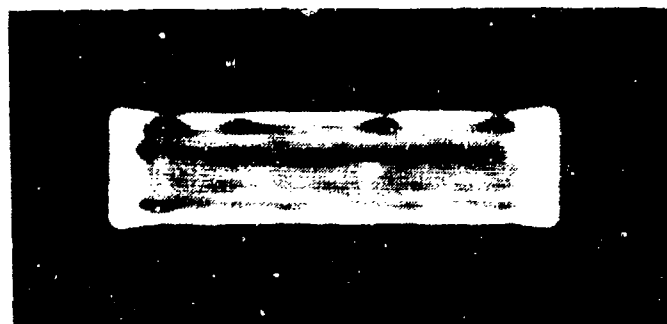
Figure 42. X-ray CT Cross-Sectional Images of Specimen  
ACCRI 1% Al<sub>2</sub>O<sub>3</sub> Oxidation Cycle.

Note: Same Sections Shown  
Metallographically  
in Figure 41.

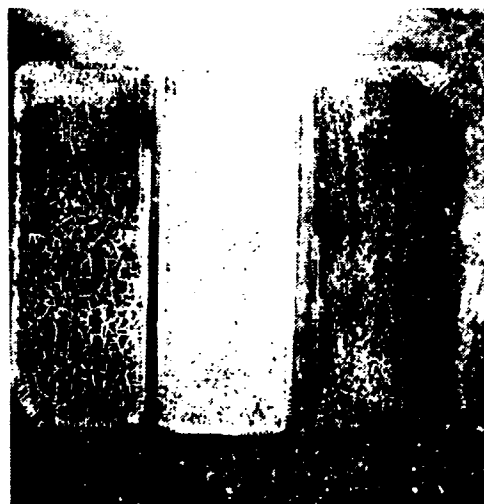
Figure 44. Differential Absorption  
Results on SFL and Chromalloy  
Coated Specimens.

(a) Specimens with SFL Coating  
on SAIC Substrate

(b) Specimen with Chromalloy on  
GAI Substrate
